March 5, 2015

AVS Flyer: New UH-1 Helicopter Switch Saves ⁰ Life

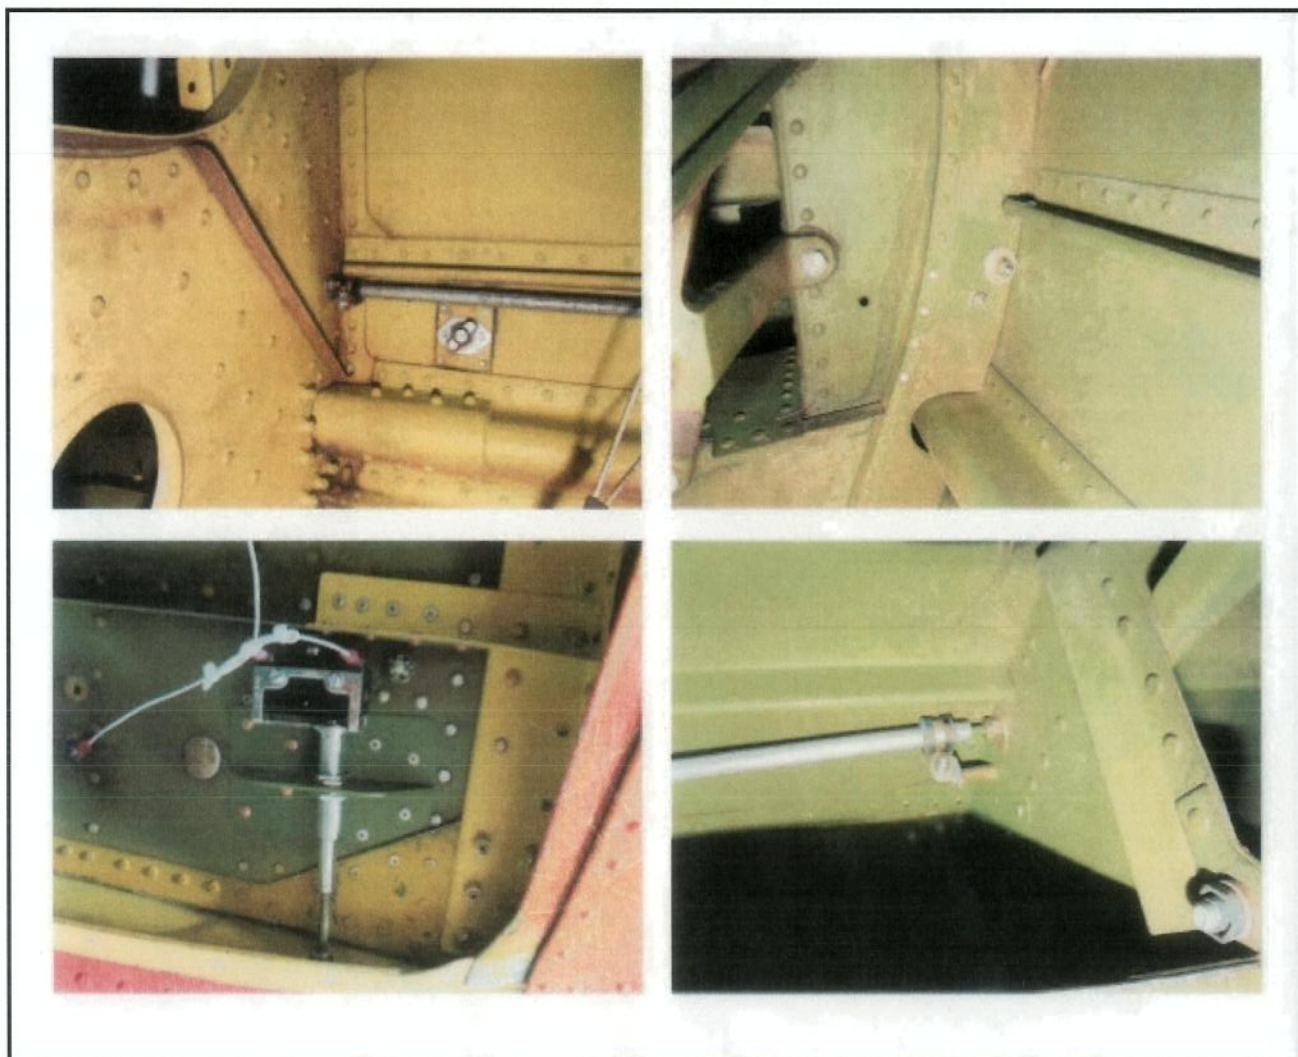
Photos of the UH-1 tail boom assembly.

On February 14, 2015, a UH-1 helicopter was conducting long line logging operations in the mountains outside of Corvallis, OR, when the pilot heard a noise and subsequently the tail boom caution indicator light came on. The pilot immediately dropped the external load and landed. Upon inspection, he found that one of the tail boom mount bolts had broken.

The tail boom is a hollow tube that extends from the rear of the helicopter frame and holds the tail case and tail rotor assemblies together with four bolts, or what is called a bathtub fitting. As a result of the vibration of the transmission on the helicopter, there have been many cases where these bolts have broken. If a pilot is unaware of the bolts loosening, safety is severely compromised and situations like this one can be fatal.

Aircraft Structural Repair, Inc. designed a switch that provides lighted notification to the flight crew if there is movement on the tail boom. They worked with the Helena Flight Standards District Office (FSDO) and the Denver Aircraft Certification Office (ACO) to inspect the modification, review the flight manual supplements and obtain design approval of the product.

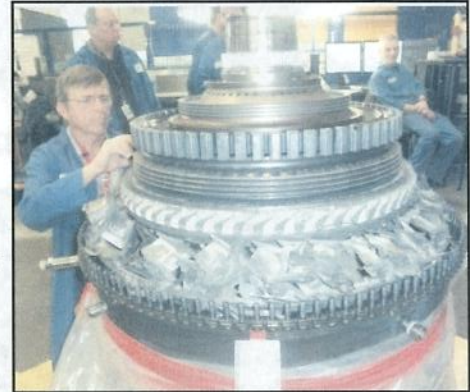
AVP-100's **Bob Hendrickson** examines the damage to the first stage of the high pressure turbine section of a GE GenEx engine from a foreign carrier.

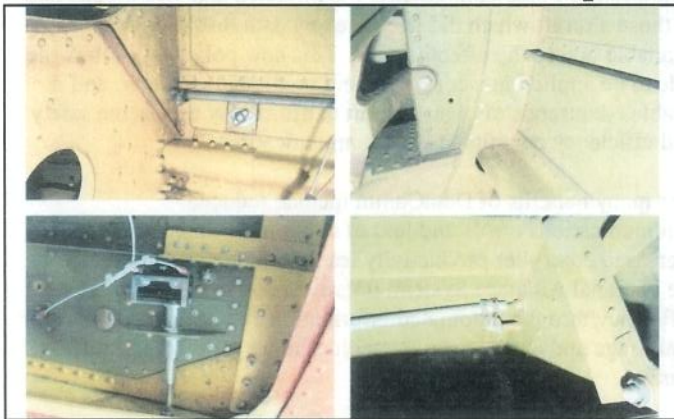
Photos of the UH-1 tail boom assembly.

On February 14, 2015, a UH-1 helicopter was conducting long line logging operations in the mountains outside of Corvallis, OR, when the pilot heard a noise and subsequently the tail boom caution indicator light came on. The pilot immediately dropped the external load and landed. Upon inspection, he found that one of the tail boom mount bolts had broken.

The tail boom is a hollow tube that extends from the rear of the helicopter frame and holds the tail case and tail rotor assemblies together with four bolts, or what is called a bathtub fitting. As a result of the vibration of the transmission on the helicopter, there

have been many cases where these bolts have broken. If a pilot is unaware of the bolts loosening, safety is severely compromised and situations like this one can be fatal.

Aircraft Structural Repair, Inc. designed a switch that provides lighted notification to the flight crew if there is movement on the tail boom. They worked with the Helena Flight Standards District Office (FSDO) and the Denver Aircraft Certification Office (ACO) to inspect the modification, review the flight manual supplements and obtain design approval of the product.
